Manhole Inspection Summary

Manhole # S29WW1002MH

Insp Date: **1/15/07 2:17 PM**

Location Address: **5015 GREENLEAF RD**

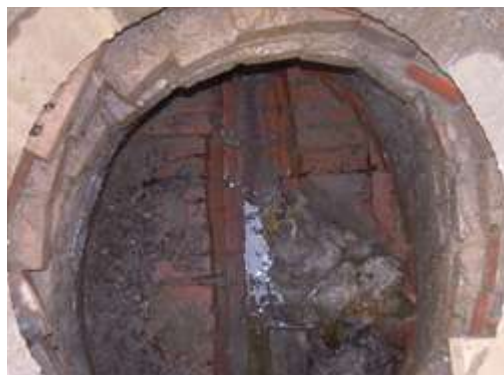
Top View

Evidence of surcharge - Bench debris.
Channel debris.

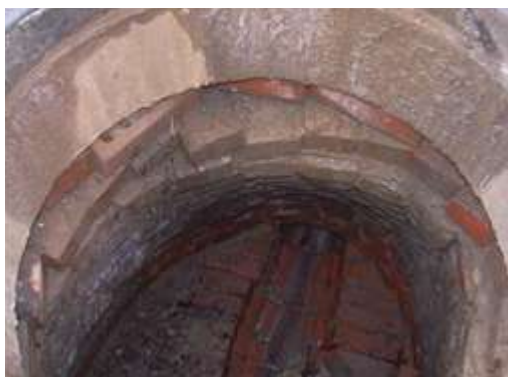
Defect

Frame leaks. Frame offset. Adjustment
deterioration, loose brick, and infiltration.
Corbel and Barrel infiltration - other side.

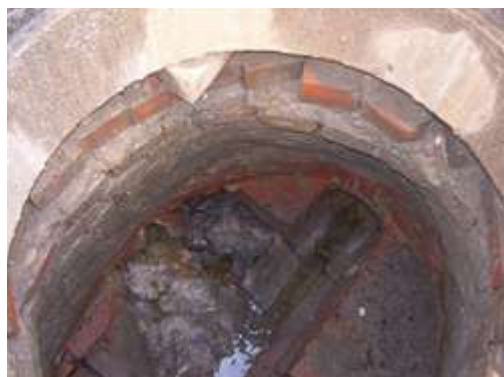
Defect

Frame leaks. Frame offset. Adjustment
deterioration, loose brick, and infiltration.
Corbel and Barrel infiltration

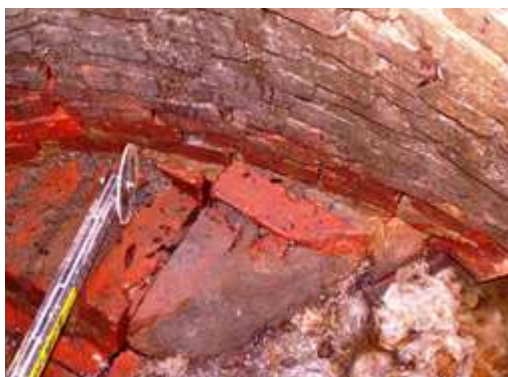
Defect

Barrel deterioration and infiltration. Bench
deterioration and cracks.

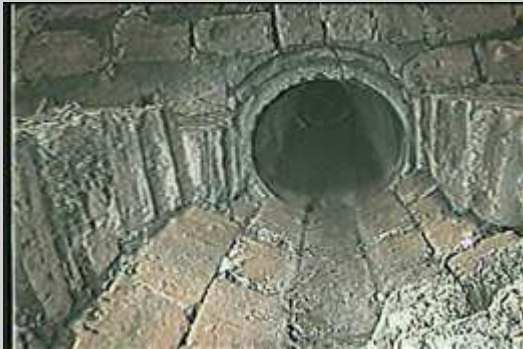
8 in. Circular Gravity Sewer Pipe Out @ 12 O'Clock

Barrel deterioration and infiltration. Channel deterioration.

Infiltration: **Evidence** Pipe Seal Cond: **Cracked**

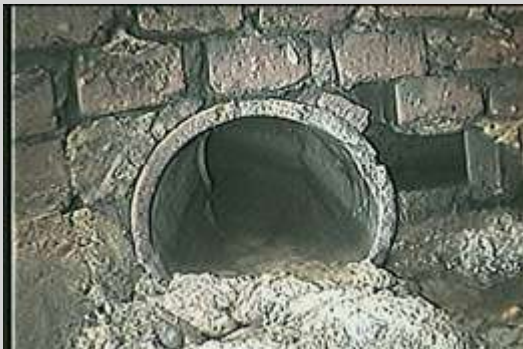
8 in. Circular Gravity Sewer Pipe In @ 4 O'Clock

Missing Barrel and Channel.

Infiltration: **Evidence** Pipe Seal Cond: **Broken**

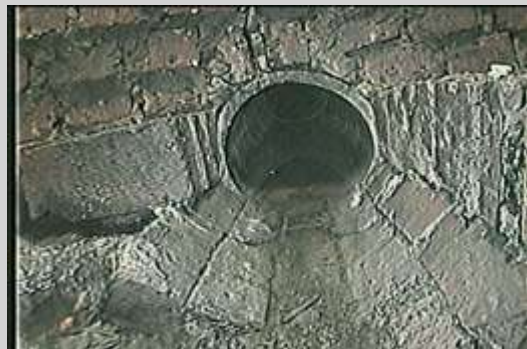
Pipe In @ 6 O'Clock

Barrel deterioration and infiltration. Channel deterioration.

Pipe Seal Cond: **Cracked**
